SITE ASSESSMENT

**MORRIS PAINT AND VARNISH COMPANY
EAST ST. LOUIS, ILLINOIS**

**U.S. Environmental Protection Agency
Region V
230 South Dearborn Street
Chicago, Illinois**

June 1990

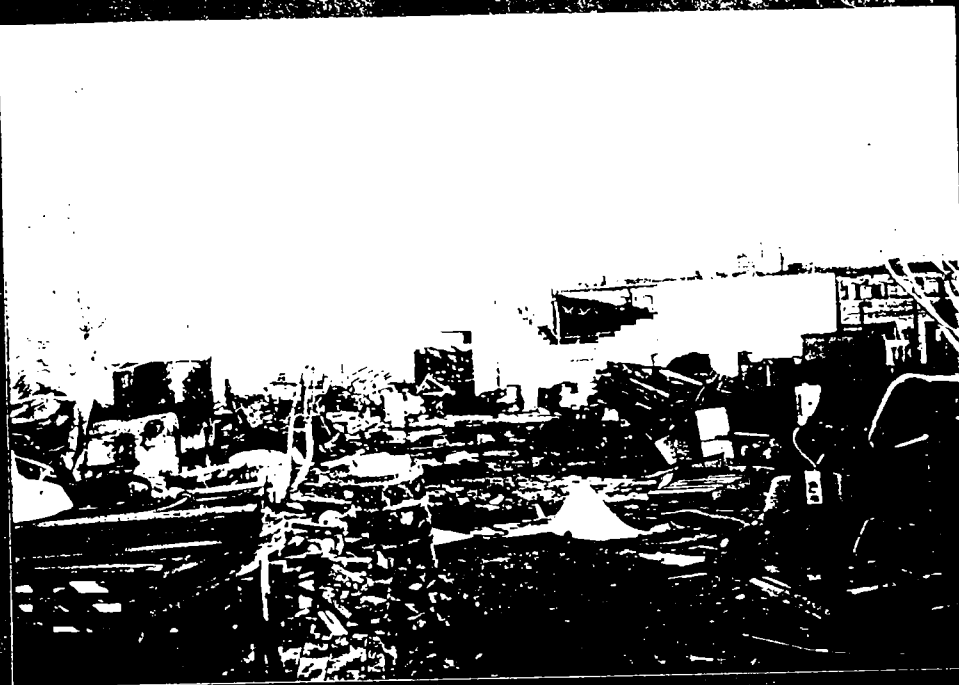
PHOTO: 1.
 SITE NAME: MORRIS PAINT CO, EAST ST LOUIS, ILLINOIS
 DESCRIPTION: DOCK AREA WITH METAL DEBRIS, DRUMS, AND
 VATS, LOOKING SOUTHEAST.
 DATE/TIME: 03-12-90/1715
 PHOTOGRAPHER: N. KUMARANAYA
 FILM: 35MM, ISO 200

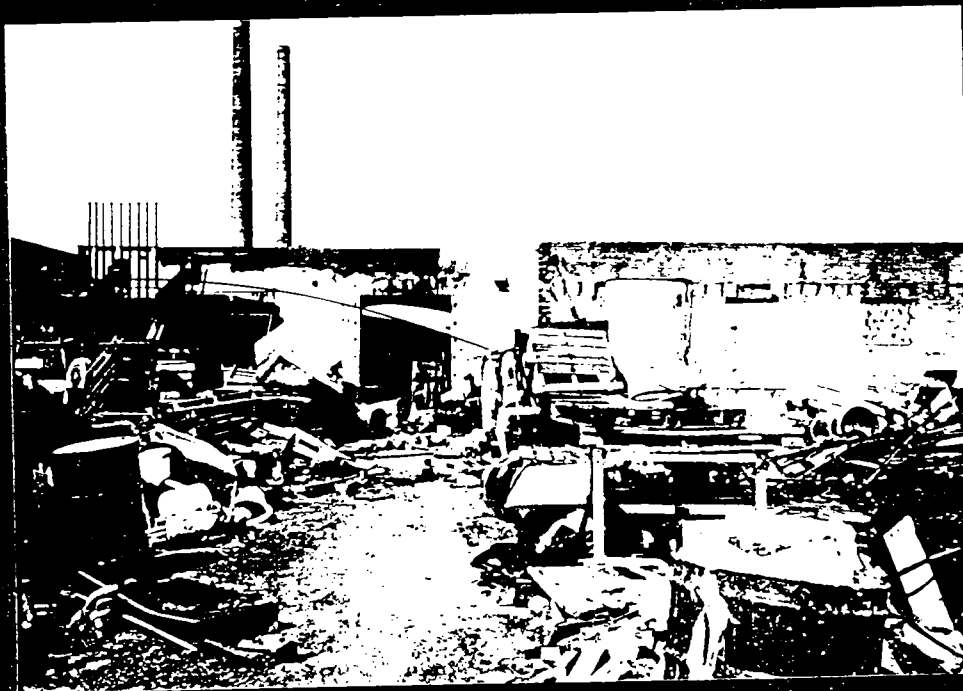
PHOTO: 2.
 SITE NAME: MORRIS PAINT CO, EAST ST LOUIS, ILLINOIS
 DESCRIPTION: DOCK AREA WITH METAL DEBRIS, DRUMS, AND
 TANKS, LEADING INTO MANUFACTURING AREA,
 LOOKING NORTHWEST.
 DATE/TIME: 03-13-90/0915
 PHOTOGRAPHER: N. KUMARANAYAGAM
 FILM: 35MM, ISO 200

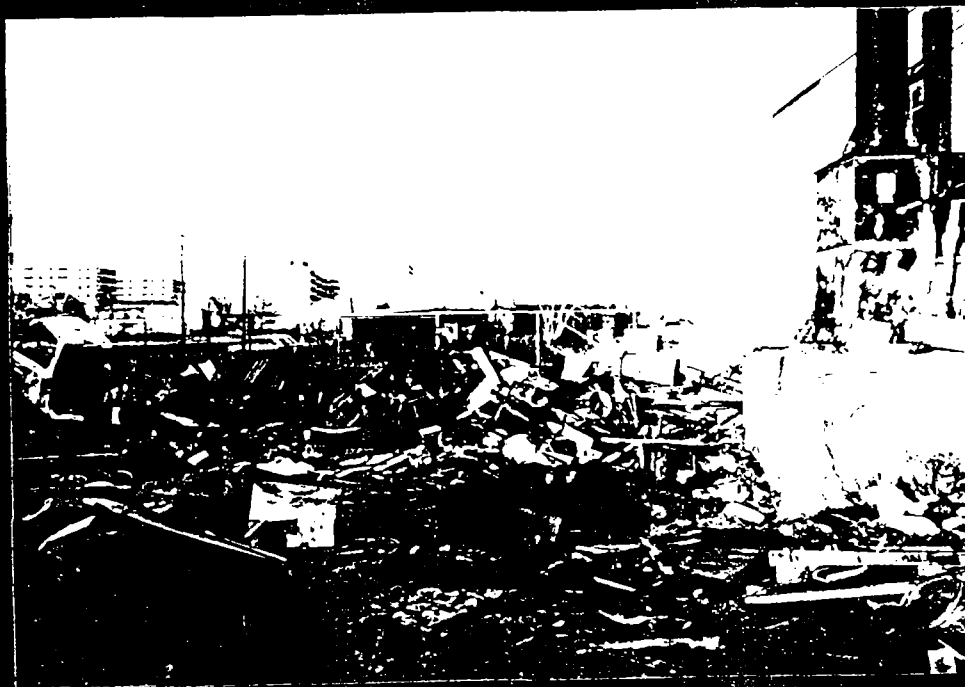
PHOTO: 4.
 SITE NAME: MORRIS PAINT CO, EAST ST LOUIS, ILLINOIS
 DESCRIPTION: NORTHWEST SIDE OF MANUFACTURING BUILDING WITH METAL DEBRIS, LOOKING NORTHEAST.
 DATE/TIME: 03-12-90/1730
 PHOTOGRAPHER: N. KUMARANAYAGAM
 FILM: 35MM, ISO 200

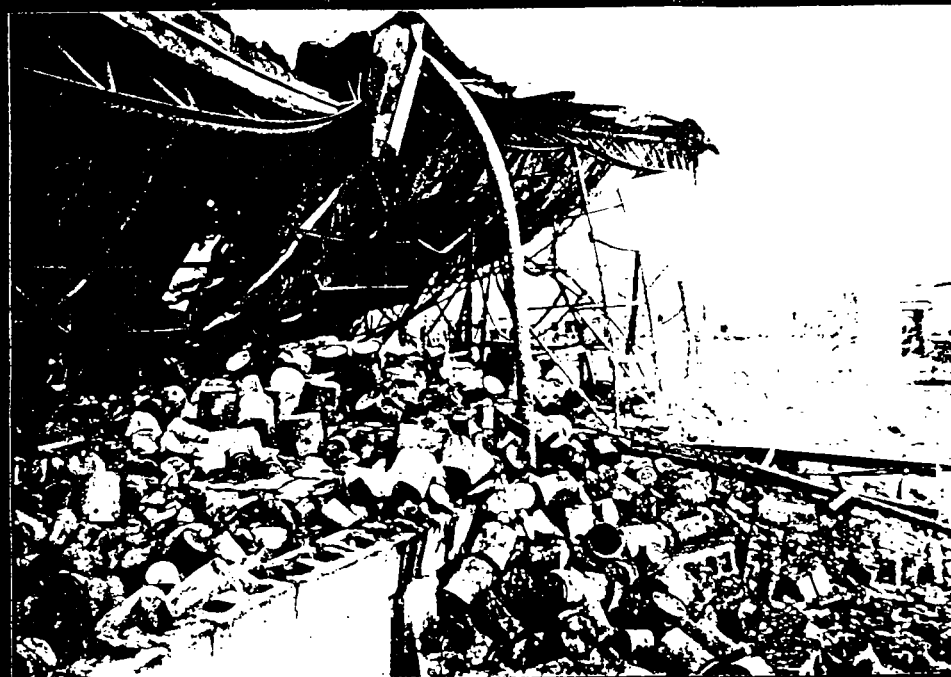
PHOTO: 6.
 SITE NAME: MORRIS PAINT CO, EAST ST LOUIS, ILLINOIS
 DESCRIPTION: COLLAPSED ROOF IN WAREHOUSE AREA WITH
 PAINT CANS, LOOKING NORTHEAST.
 DATE/TIME: 03-13-90/1012
 PHOTOGRAPHER: N. KUMARANAYAGAM
 FILM: 35MM, 1SC 200

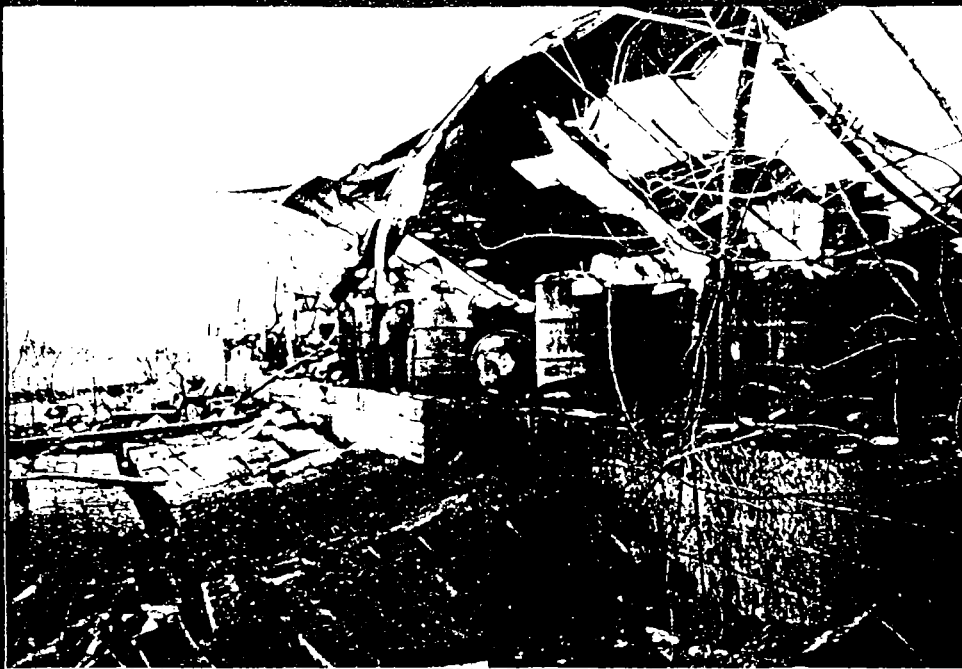
PHOTO: 7.
 SITE NAME: MORRIS PAINT CO, EAST ST LOUIS, ILLINOIS
 DESCRIPTION: NORTHEAST SIDE OF WAREHOUSE AREA WITH
 DRUMS, COLLAPSED WALL OF BUILDING ON
 GROUND, LOOKING SOUTHEAST.
 DATE/TIME: 03-12-90/1742
 PHOTOGRAPHER: N. KUMARANAYAGAM
 FILM: 35MM, ISO 200

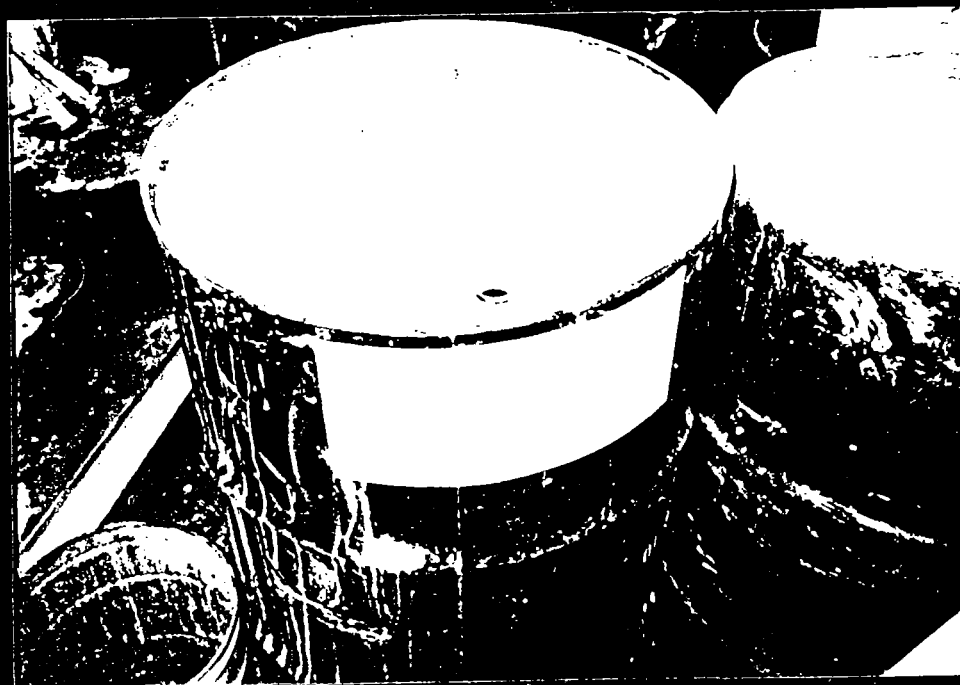
PHOTO: 10.
 SITE NAME: MORRIS PAINT CO, EAST ST LOUIS, ILLINOIS
 DESCRIPTION: DRUM CONTAINING TOLUENE, IN MANUFACTURING
 AREA.
 DATE/TIME: 03-13-90/1030
 PHOTOGRAPHER: N. KUMARANAYAGAM
 FILM: 35MM, ISO 200

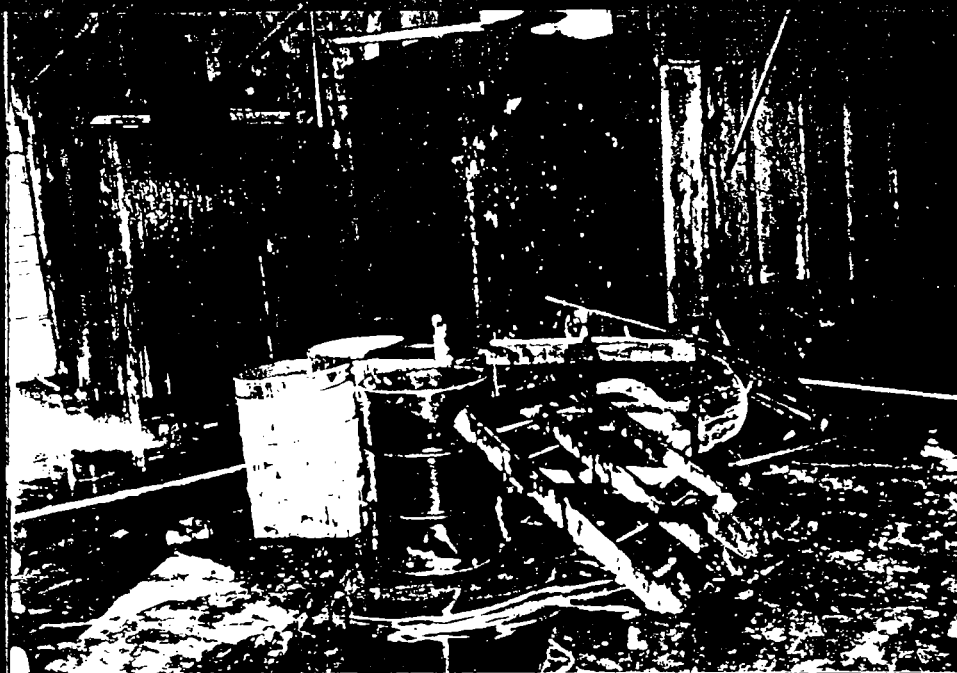
PHOTO: 11.
 SITE NAME: MORRIS PAINT CO, EAST ST LOUIS, ILLINOIS
 DESCRIPTION: VARNISH LIKE MATERIAL ON FLOOR, AND VATS IN MIXING AREA.
 DATE/TIME: 03-13-90/1036
 PHOTOGRAPHER: N. KUMARANAYAGAM
 FILM: 35MM, ISO 200
